# GUIDELINES FOR CONVENTIONAL AND THIN WHITETOPPING

*(First Revision)*

**INDIAN ROADS CONGRESS  
2015**

## DEMONSTRATION PROJECT OF TWT

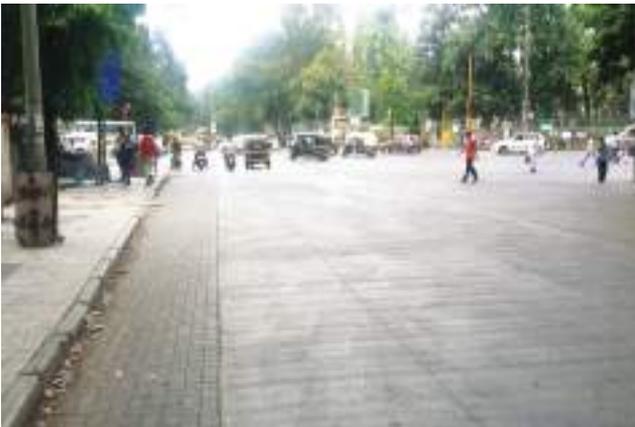
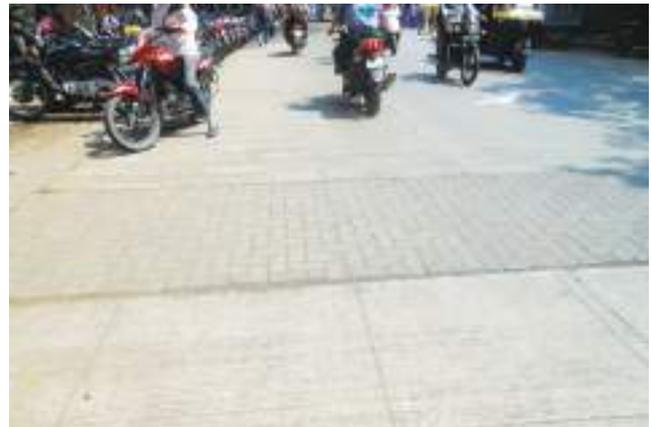
- **Location:** Road in front of Shivajinagar State Transport depot. Total length of the road is 1.26 km and carriageway width is 11.00 m ROW is 15/18 m.
- **Type of Treatment:** Thin White topping with thickness 175 mm M40 grade concrete overlaid on top of existing bituminous road after milling of 50 to 60 mm.
- **Panel Size:** 1 m x 1 m panels created by saw cutting joints within 24 hours of casting. Width of TWT treatment is 8 m and hence 4 m wide concrete is cast first and then the balance 4 m width is cast after completion of curing and joint sealing (approx. 21 days) on other side. Longitudinal joint is not saw cut and butt joint is kept as it is.
- **Dowel Bars and Tie Bars:** Dowel bars are used only at the construction joint (25 mm bars at 250 mm c/c). Tie bars are used only at the center of the road (longitudinal joint 12 to 16 mm tor steel at 400 c/c)

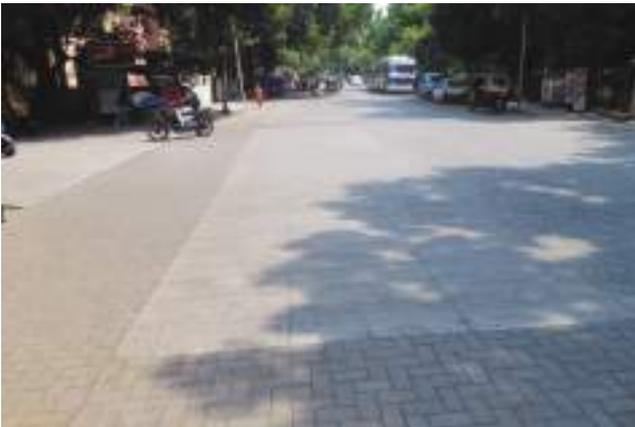
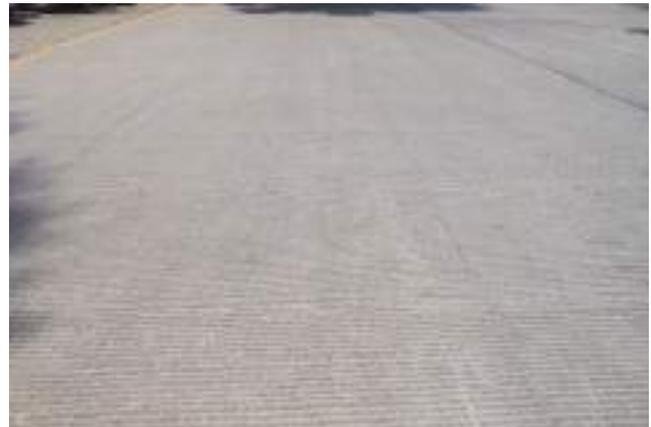
- **Assessment of Existing Road:** The Benkelman Beam Deflection study was carried out on the existing BT surface to design the bonded overlay treatment as per IRC:SP:76 and IRC:58 guidelines.
- **Milling Operation and Pretreatment:** Milling of existing BT road was done with a milling machine and 50 to 60 mm bituminous layer removed to lower the level of the road as well as creation of bond for concrete overlay. The portions which showed structural defects and settlement (approx. 1 to 2 percent of area) were completely excavated and new layers of hard moorum, GSB and DLC were provided.
- **Mix Design:** M40 grade concrete was used for the work with fibrillated Polypropylene fibers. On-site slump of concrete, prepared in a RMC plant, was kept below 40 mm. The cement content and w/c ratio were kept at 420 kg per cum and 0.37 respectively.

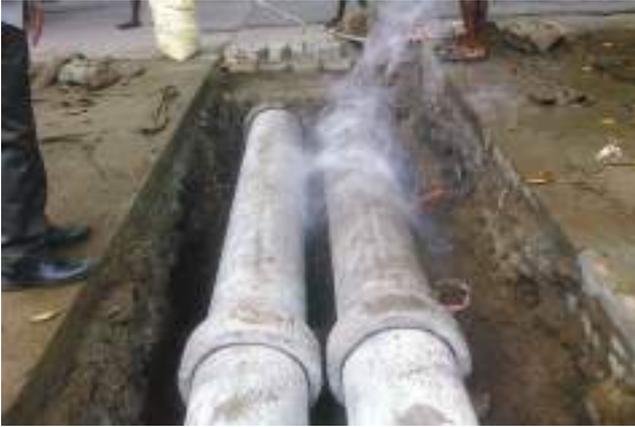
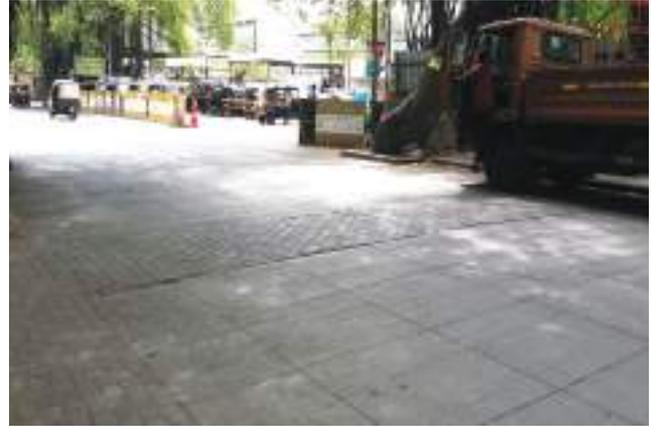
1. RCC cross pipes of 300 mm and 450 mm dia are provided at every 50 m interval in congested area to cross utilities at a later stage without cutting the road. The area above pipes is paved with paver blocks.

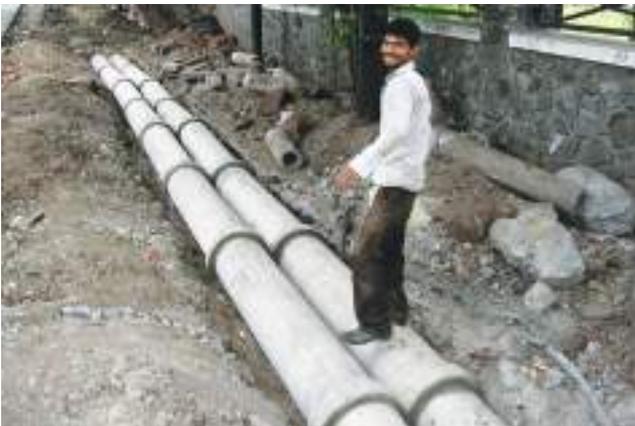
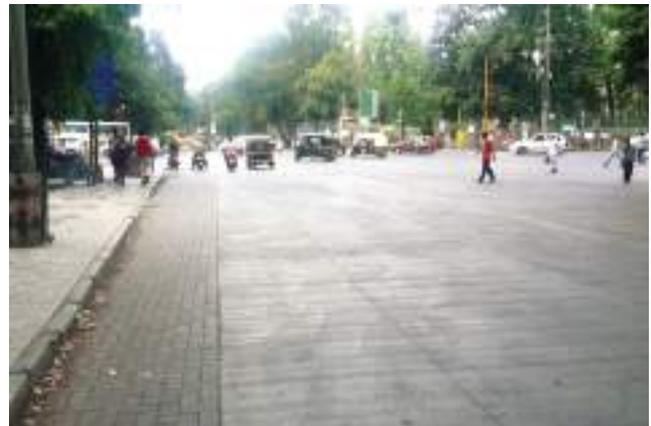
2. RCC piles are also provided in the longitudinal direction along the road edge to house utility lines like OFC cables, Electrical cables etc and chambers with openable covers are provided at every 15 m interval. The pipe section is also provided with 100 mm removable paver blocks on a concrete bed.

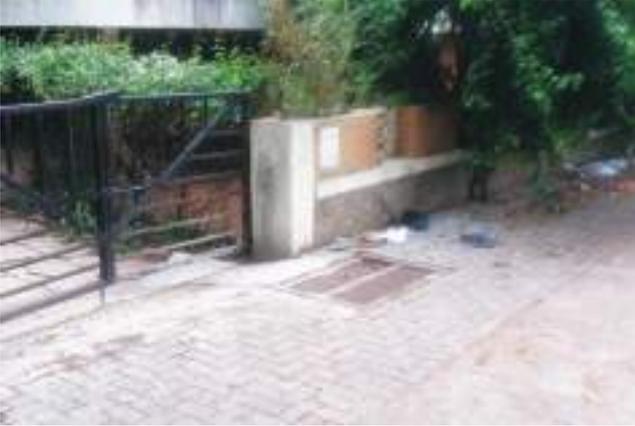
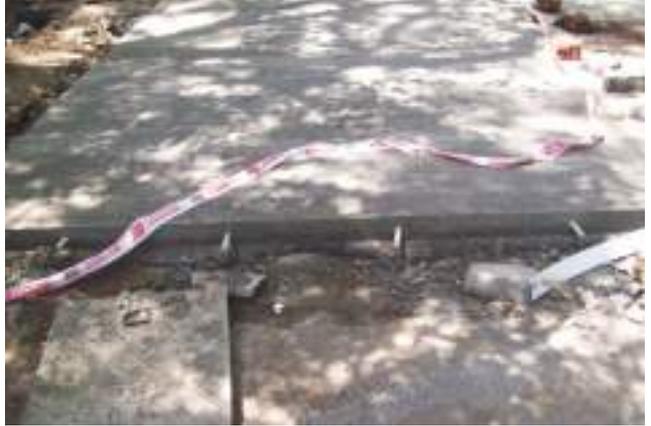
3. Adequate storm water drainage arrangement in the form of collection chambers in individual property, ramps in direction opposite to property entrance (to prevent water entry in property) are provided.

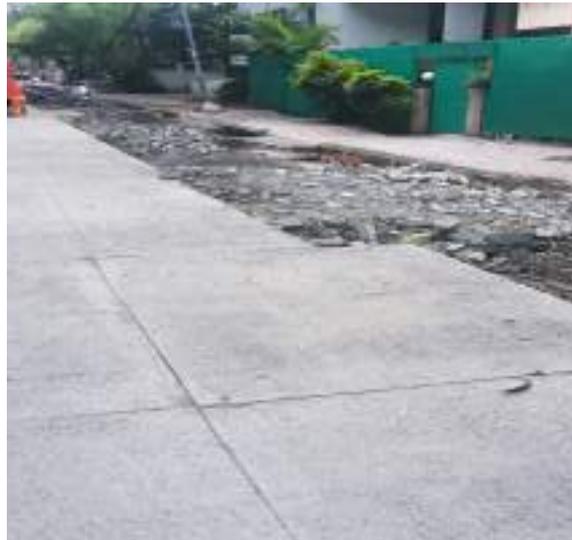
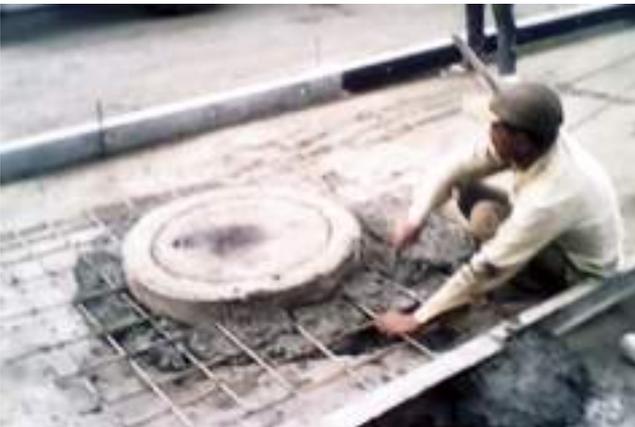
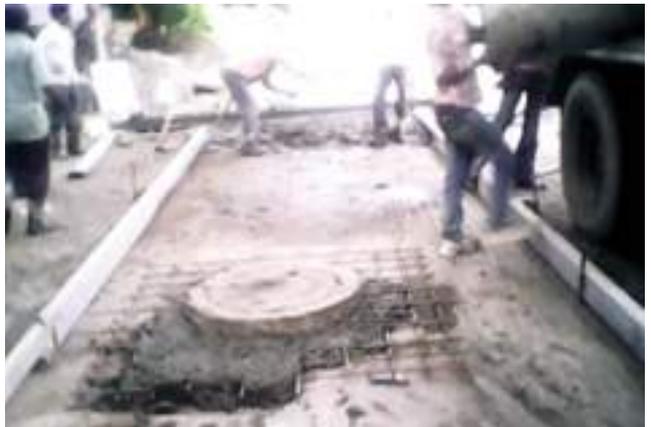
4. Dowel bars are provided only at construction joint and the tie bars only at central longitudinal joint.
5. The RCC mesh of 12 mm dia 150 mm c/c (single mesh) is provided around the sewer/manhole chamber frame for a section of 1.5 m X 1.50 m for strengthening of the section around the manhole chamber cover.

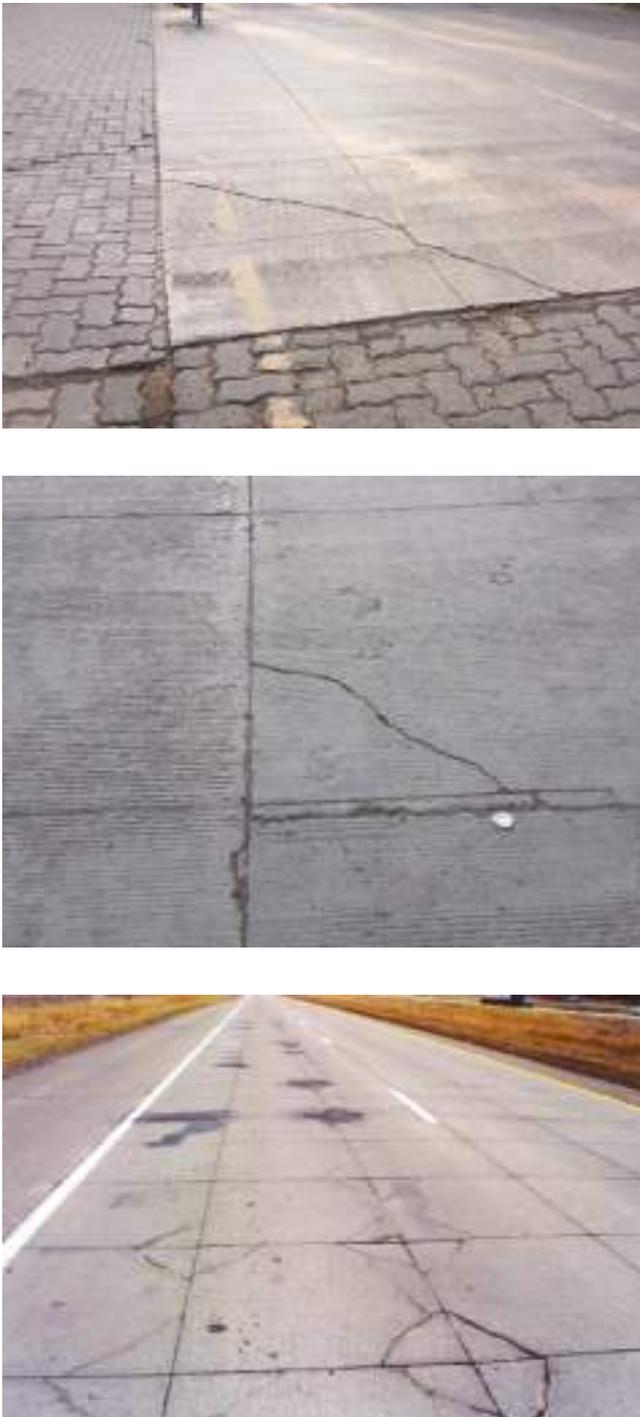
| <b>CORNER BREAK/CORNER CRACKING</b> | <b>Cause</b> | <b>Remedy</b> |

| <b>CORNER BREAK/CORNER CRACKING</b> | <b>Cause</b> | <b>Remedy</b> |
|--|--|---|
| | <p>Corner cracking appears to be the primary failure mode, and fatigue cracking is believed to be the primary failure mechanism in TWT/UTWT. Bonding is an important factor to long-term performance of the overlay. TWT/UTWT provides small joint spacing to minimize restraint stress. However, joint locations and traffic loading should be given significant consideration. In case of loss of support from the underlying HMA layer over time, corner breaks are likely to occur under heavy wheel load.</p> | <p>Full-panel replacement is common repair strategy for the distressed panels of TWT/UTWT such as Corner breaks</p> |

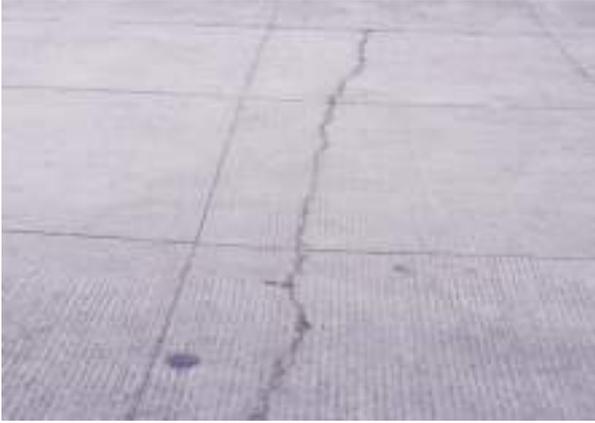
| <b>TRANSVERSE CRACK</b> | | |

| <b>TRANSVERSE CRACK</b> | | |
|---|--|--|
| | Late joint sawing, misalignment of the dowel bars at construction joints leads to transverse cracking. | Make 8-10 mm wide groove along the crack for a depth of 20 mm and refilling with approved sealant. |

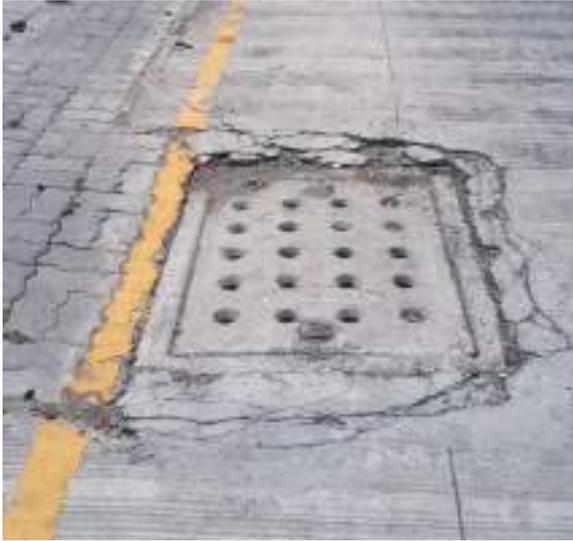
| <b>TRANSVERSE CRACK</b> | | |
|---|--|--|
| <b>DAMAGED UTILITY CHAMBERS</b> | | |

| <b>TRANSVERSE CRACK</b> | | |
|---|--|--|
| | Use of masonry to raise the utility chambers to the road level during overlay operation. Improper workmanship and lack of adequate protection of the edges of the utility chamber. | Raising of utility chambers likely to come in the carriageway should be done in concrete (preferably whole chamber should be recast in concrete).<br>Adequate protection of 0.3 m portion around the chamber should be strengthened using nominal steel mesh |

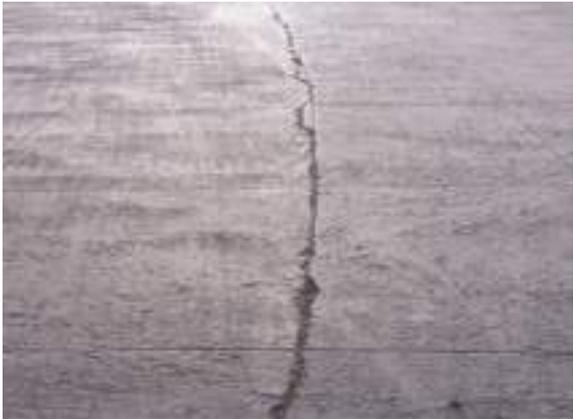
| <b>TRANSVERSE CRACK</b> | | |
|---|--|--|
| <b>DAMAGED LONGITUDINAL JOINT</b> | | |

| <b>TRANSVERSE CRACK</b> | | |
|---|--|--|
| | Poor workmanship, bent steel formwork during construction and unprotected concrete edge after construction results in zigzag longitudinal joint which later on opens up and prone to damage after saw cutting. | Use good and strong formwork during construction and make sealing groove along the longitudinal construction joint |

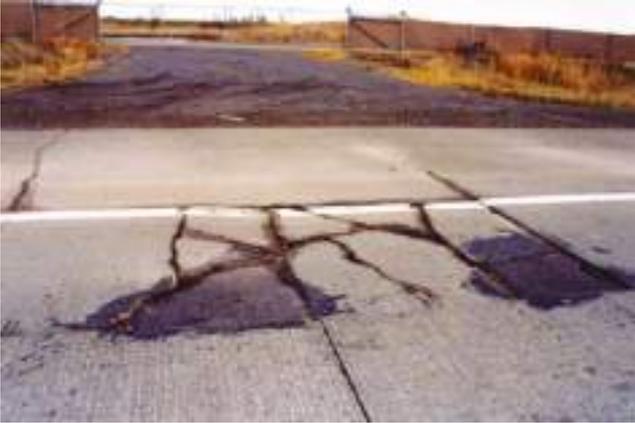
| <b>SHATTERED PANELS</b> | | |

| <b>SHATTERED PANELS</b> | | |
|---|---|---|
| | Settlement and damage of underlying bituminous layer leading to cracking and shattering of panels | Full depth repair of damaged panels |
